WHITE PAPER

Hull Coating Degradation - the Hidden Cost

**How to avoid large fuel penalties,
without repeated drydocking
and hull repainting**

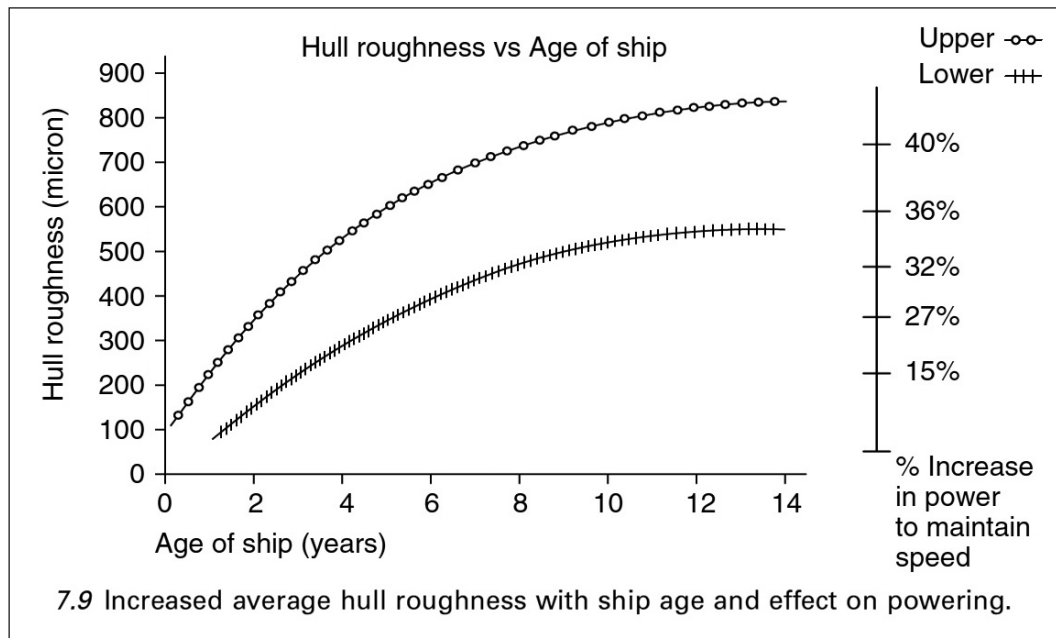
Advances in marine antifouling coatings and technology, entitled “The effects of corrosion and fouling on the performance of ocean-going vessels: a naval architectural perspective,” include useful information and a graph concerning hull roughness compared to age of ship.⁹

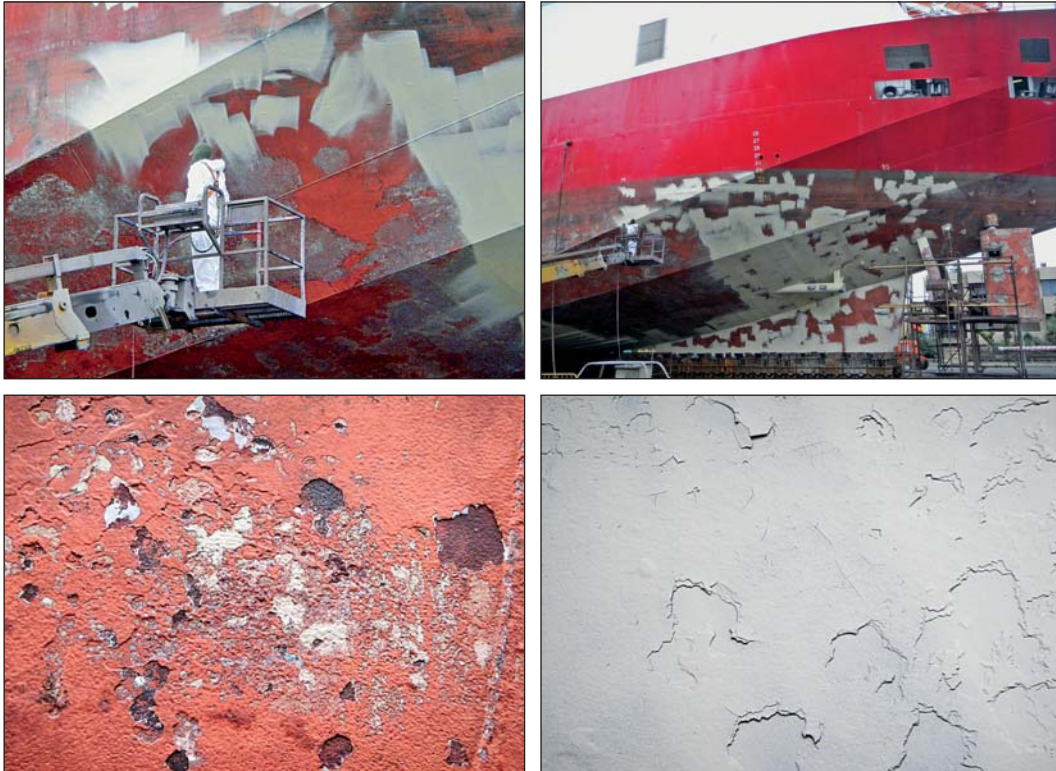
(Above) Hull coating repair as currently practiced. (Below left) The results of coating degradation and repair. (Below right) Completed coating repair showing a very rough hull.

Some photos will illustrate the problem, the repair and the results:

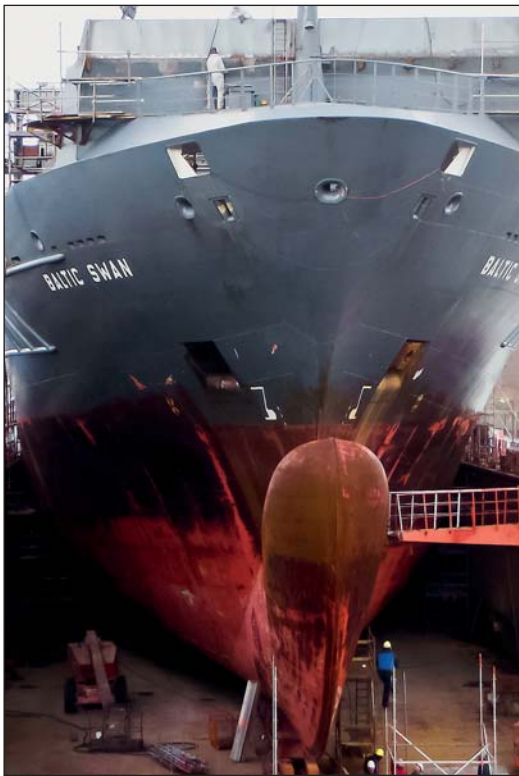
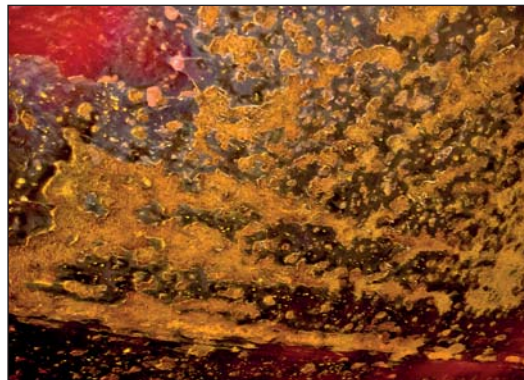
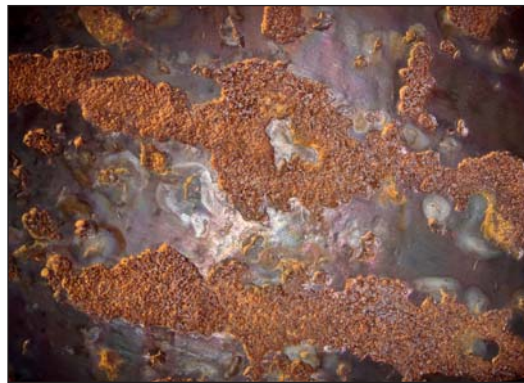
MV Baltic Swan after 4 years service with conventional hull coating (above).

Baltic Swan, owned and managed by Peter Doehle of Hamburg. The *Baltic Swan* is a 149 meter, 13,713 tons DWT container ship built in 2004. The first set of photos show the state of the hull coating in March 2008 after trading in ice. At that point the conventional coating was four years old. The photos were taken after cleaning but before blasting. The hull was then grit blasted and a glassflake vinylester surface treated coating (STC) was applied. Two years later after sailing between Rotterdam, Hamburg and Saint Petersburg in harsh conditions including first-year ice, and with routine in-water hull cleaning, the ship was returned to drydock in 2010 and the hull inspected. The second set of photos shows the results of that inspection.

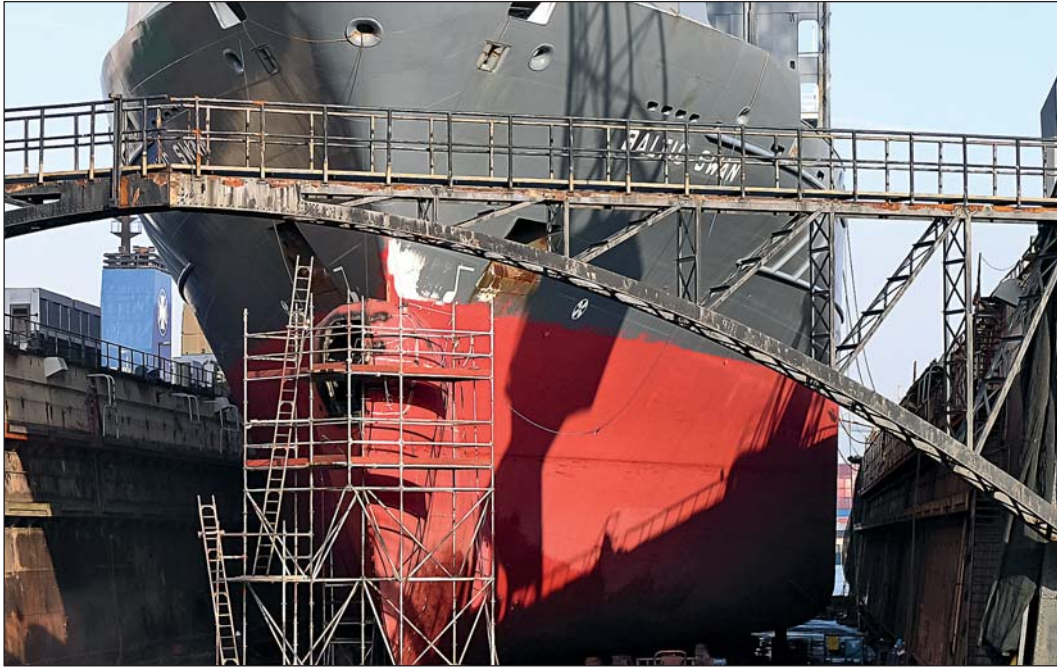
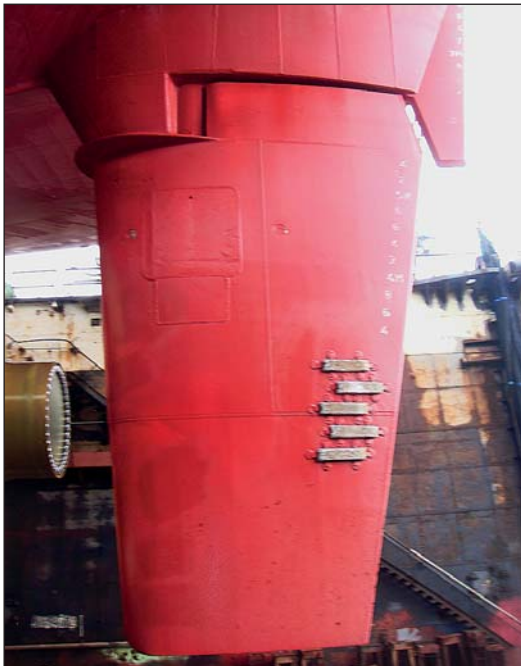
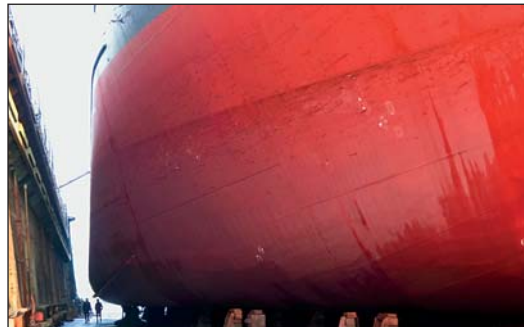
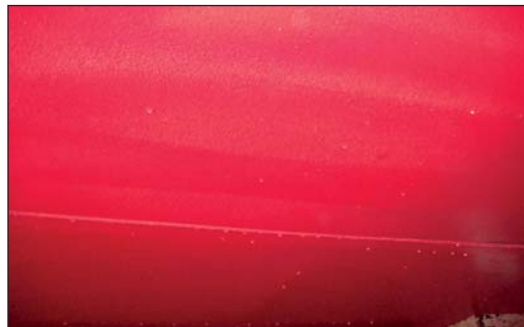
Above 4 photos show the hull after 2 years of service with STC in harsh conditions with no repair needed

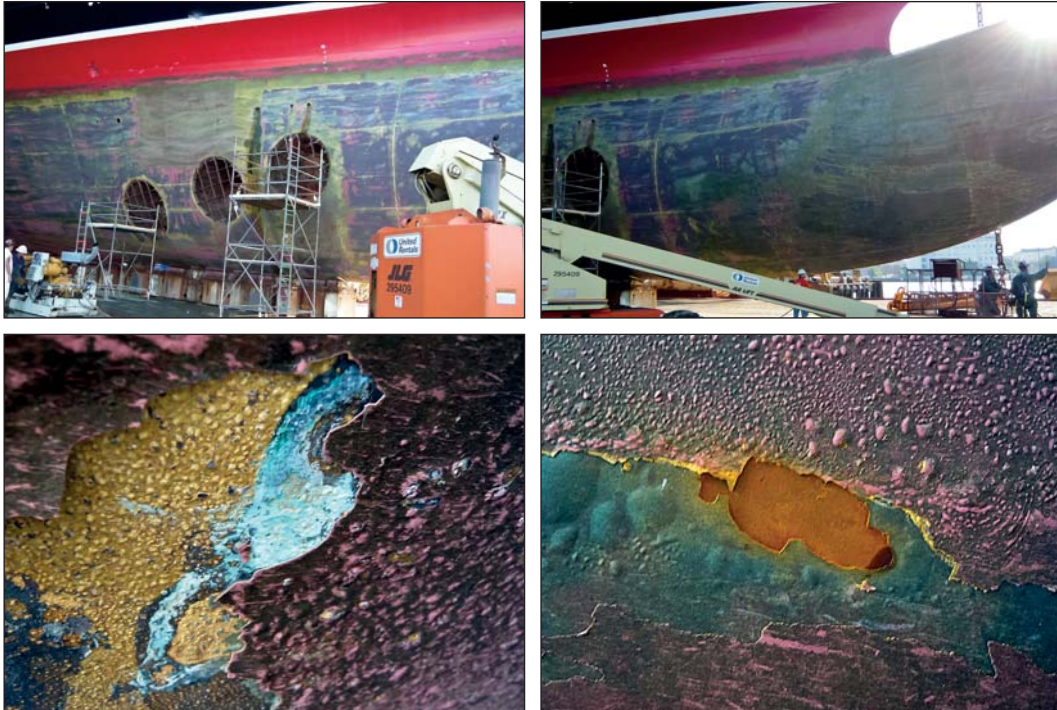
(Above) Condition of cruise ship hull 10 years after initial launch, with usual spot repairs and partial repainting during that time.

(Below) The same hull, two years after application of glassflake vinylester resin STC and routine in-water cleaning, showing almost no damage to the coating and no coating deterioration.

The second example is of an 80,000 ton cruise ship finished in 1998. The ship used conventional antifouling for the first 10 years of its life with the usual drydocking and repairs. In 2008 it was blasted back to bare steel and recoated with an STC. The first set of photos show the state of the hull before the

old coatings were blasted off. The second set of photos shows the state of the coating when the ship was drydocked two years later. It had been cleaned routinely in the water. The hull had a slime layer when drydocked and this was pressure washed.

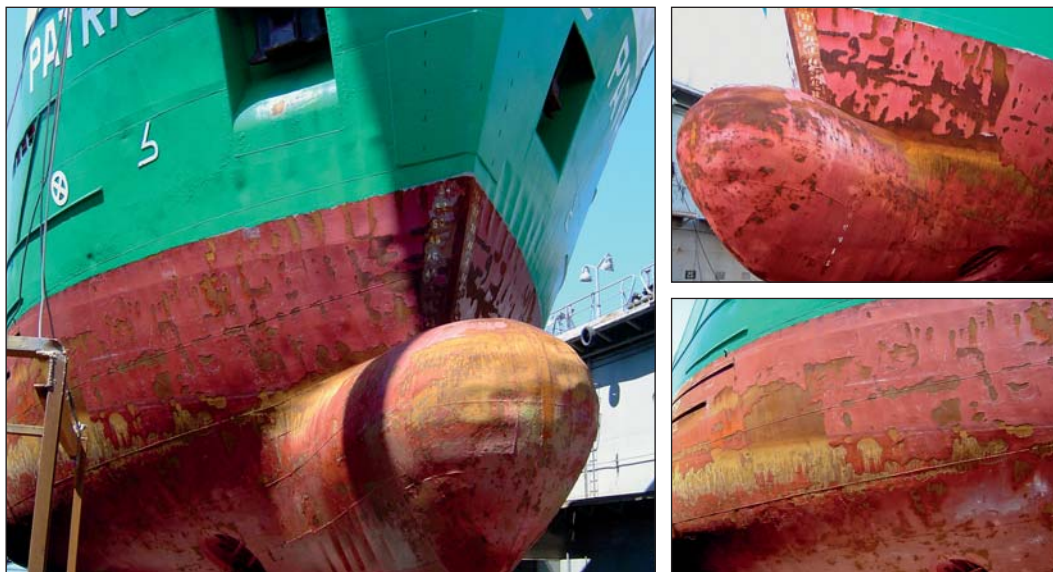
(Above) The hull 6 years after launch, using conventional antifouling coating which had been repaired in drydock 2 - 3 years before.

(Below) The hull 1 1/2 years after STC was applied, ship trading in very harsh conditions (ice).

The third example here is of MV *Patriot*, owned by Interscan of Hamburg, Germany. Built in 1994, the *Patriot* is a 3,000 ton 82-meter cargo ship. Its trading takes it into first-year ice. The first three photos show the hull's condition in June 2005, two to three years after the last drydocking and conventional hull paint was applied. The photos were taken after the hull was cleaned

and before it was blasted and an STC was applied. The second set of photos show the hull after a year and a half of trading in harsh conditions with an STC on the hull. The third set of photos show the hull after four years of service. Some very small spots of mechanical damage needed to be repaired but the hull is still as smooth as when the STC was first applied.

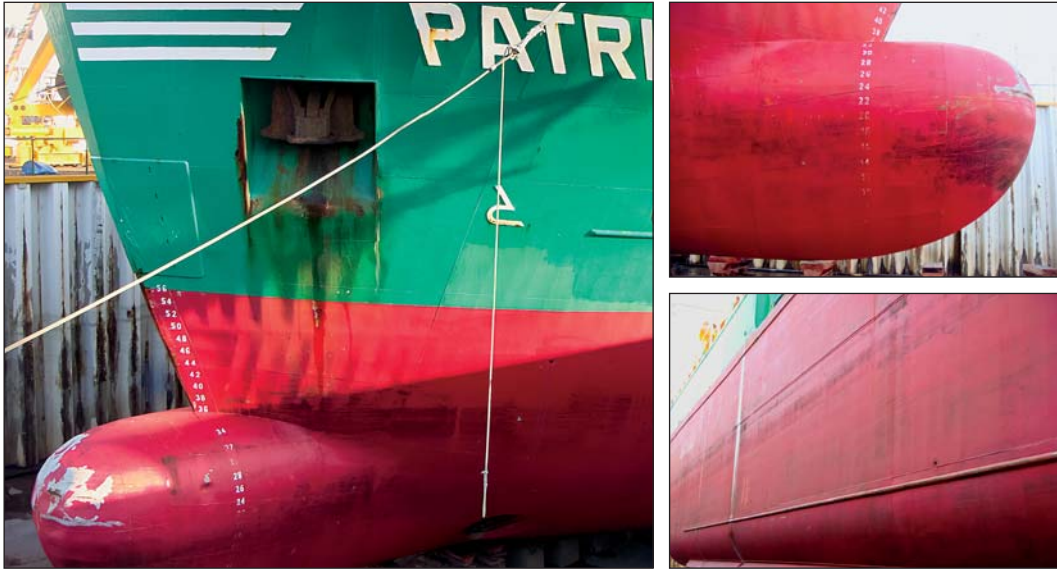
(Above) The hull 4 years after STC was first applied, with no significant repair to the coating.

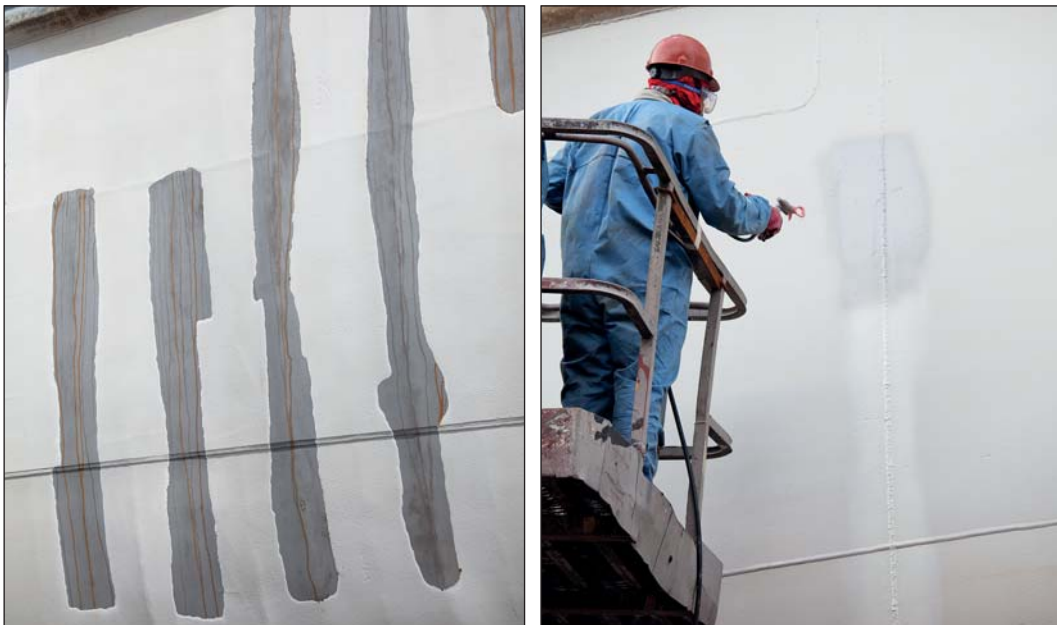
(Above) Damage to coating from welding on the inside of the hull being repaired by spraying on two coats of STC to match the coating thickness of 1000 microns.

The next example shows a hull coated with an STC which had to be repaired due to internal welding on the hull. The coating obviously did not survive the heat from the welding and the external hull strips where the paint was damaged by the welding had to be recoated. Due to the nature of the STC, no primer was needed. The strips were blasted

and then recoated with two coats of the STC which blended in well to the rest of the hull. This coating had been on the ship for two years and despite regular cleaning, including removal of very heavy calcareous fouling after the ship was laid up for nine months, was in pristine condition (and still is).

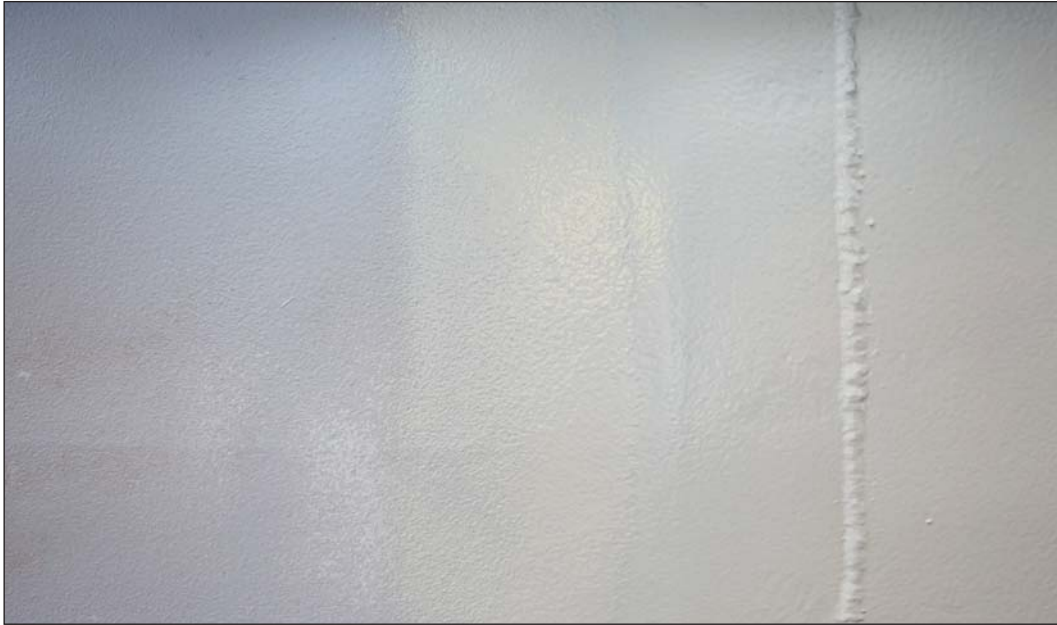
(Above) The finished repair leaves the hull as smooth as when the coating was applied several years earlier.

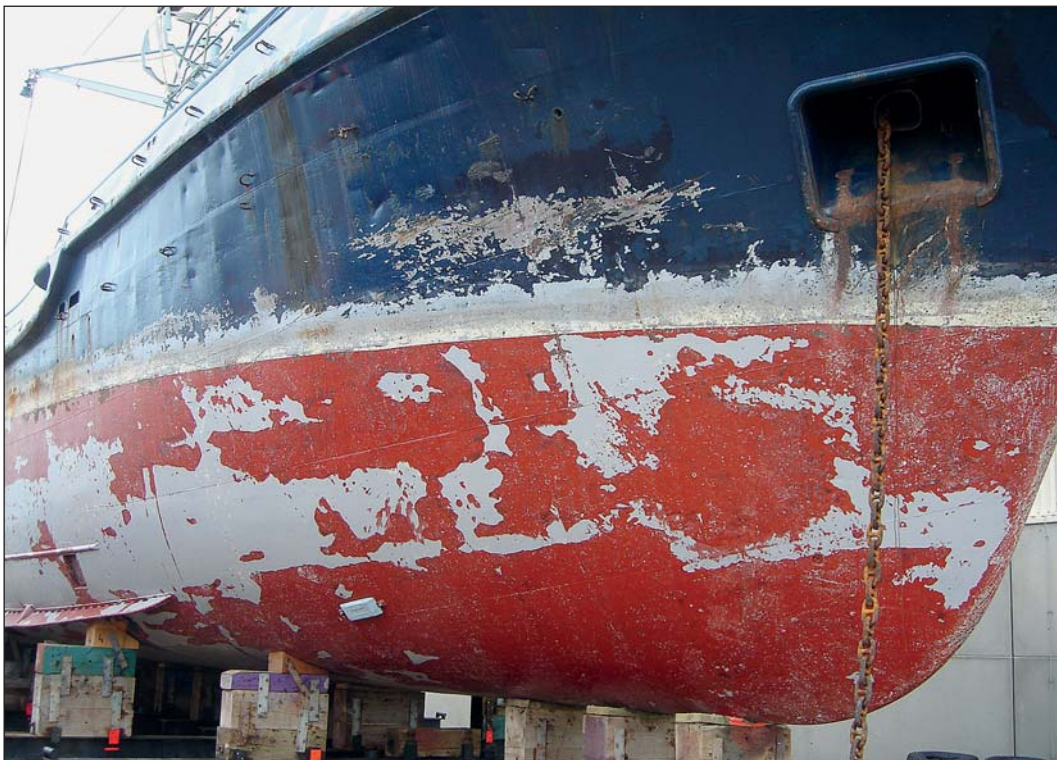
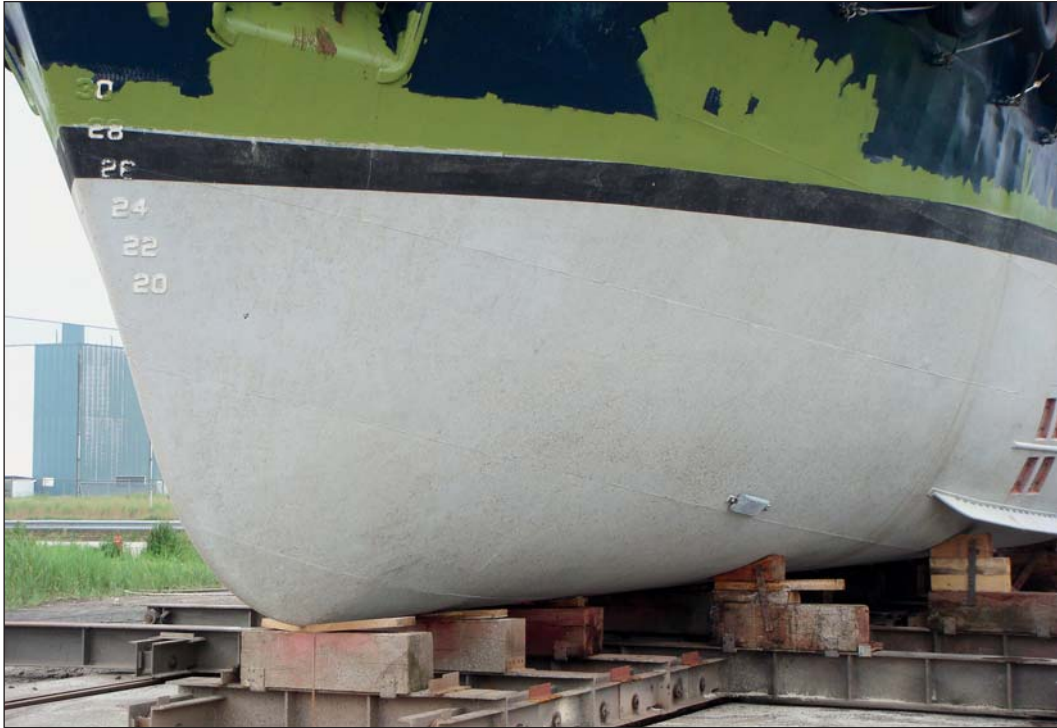
The ship below, the tug *Valcke*, was coated with an STC in 2005. The first photo shows the hull (with a silicone FR) prior to preparation and coating with the STC. The second photo shows the same hull after 5 years with

the STC in service and with no repairs in the interim. The hull is still smooth and in excellent condition and shows no sign of coating degradation.

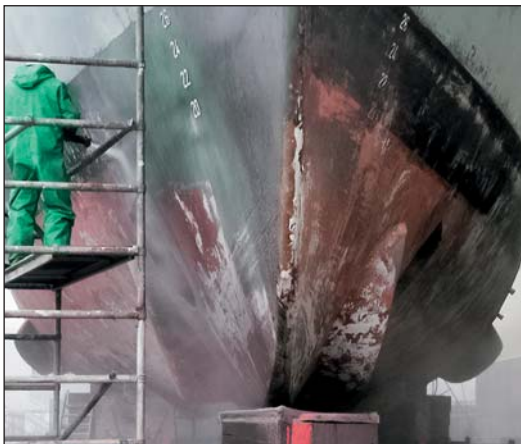
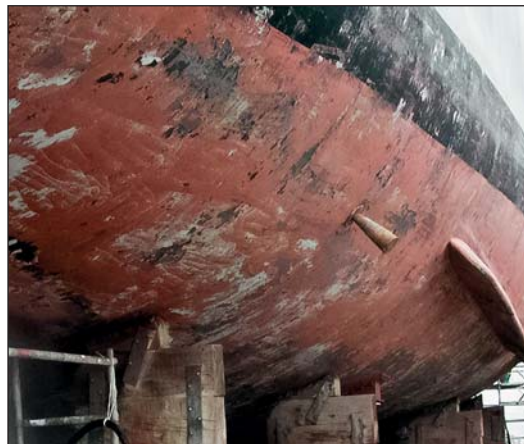
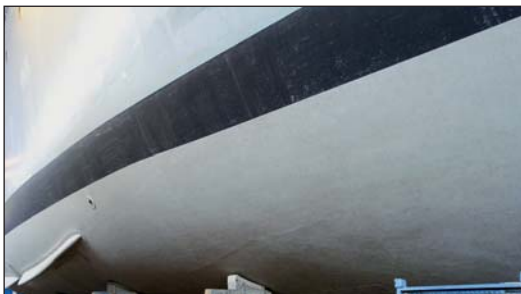
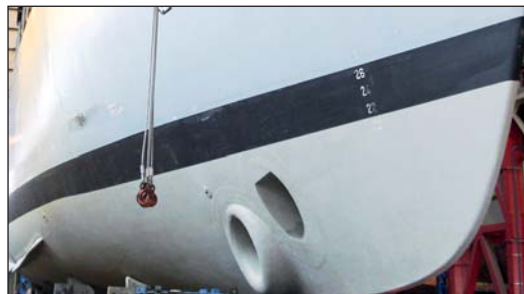
The following photos show the state of an STC after five years in service with no repainting compared to the previous state of

the hull after a few years in service. These photos show the fiberglass hulls of two naval mine hunters.
